REPETITIVE LOADING MODEL TESTS  
OF  
PRESTRESSED RIGID PAVEMENT ON  
A LOW STRENGTH SUBGRADE

TECHNICAL REPORT NO. 4-28

MAY 1964

OHIO RIVER DIVISION LABORATORIES

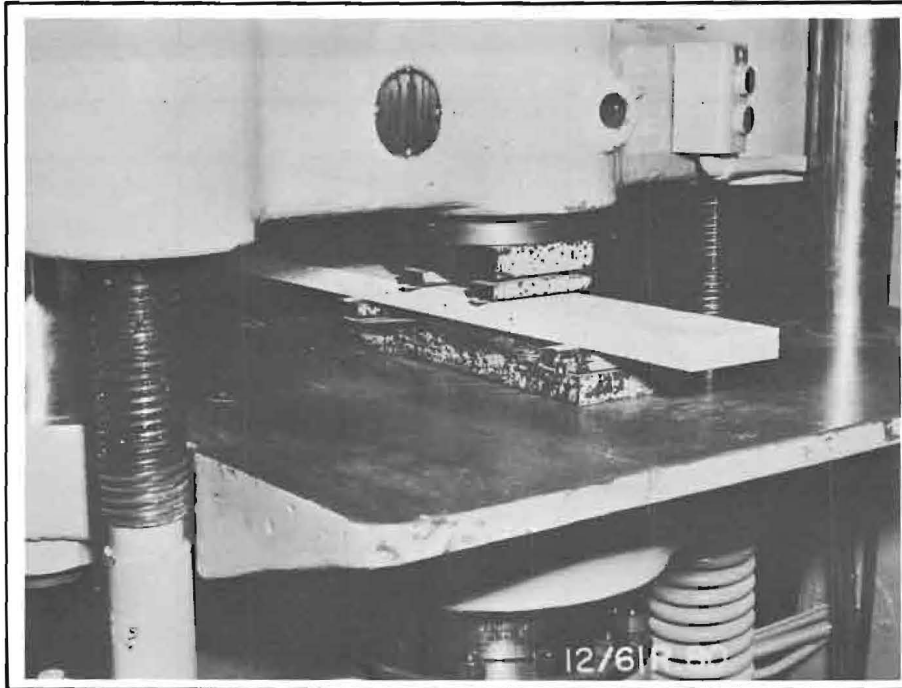
Figure 2. Set-up used for determining slab strength (flexural strength plus prestress) after completion of traffic tests. 1" x 4" x 30" beams were sawed from untrafficked areas of slabs and subjected to third-point loading.

b. "After-Traffic" Beams. Following completion of the loading tests for each slab, beams for flexural strength tests were sawed from portions of the slab outside the test area. These beams were approximately 3.8 inches wide and 30 inches long, and were sawed so as to contain a single prestressing wire at the longitudinal centerline of the beam. Thus each beam was prestressed longitudinally during the flexural strength tests, and the indicated failure stress represented a summation of the flexural strength and prestress. These beams were tested in flexure with third-point loading on a span of 13.5 inches. Owing to the eccentricity resulting from not being able to position the longitudinal prestressing wires exactly at mid-depth in the slab, two tests as follows, were made on each beam: (1) the beam was tested on one end in the "normal" or as-cast position, and (2) the beam was turned over and tested on the opposite end in the "reverse" or upside down position. By averaging the cracking stress obtained from the two tests, it was possible to eliminate any error introduced by the eccentricity of the prestressing wire. The actual flexural strength then was obtained by subtracting the computed prestress from the average cracking stress. A summary of the results obtained from the "after-traffic" beam tests is given in Table 2. The set-up used in making these tests is shown in Figure 2.

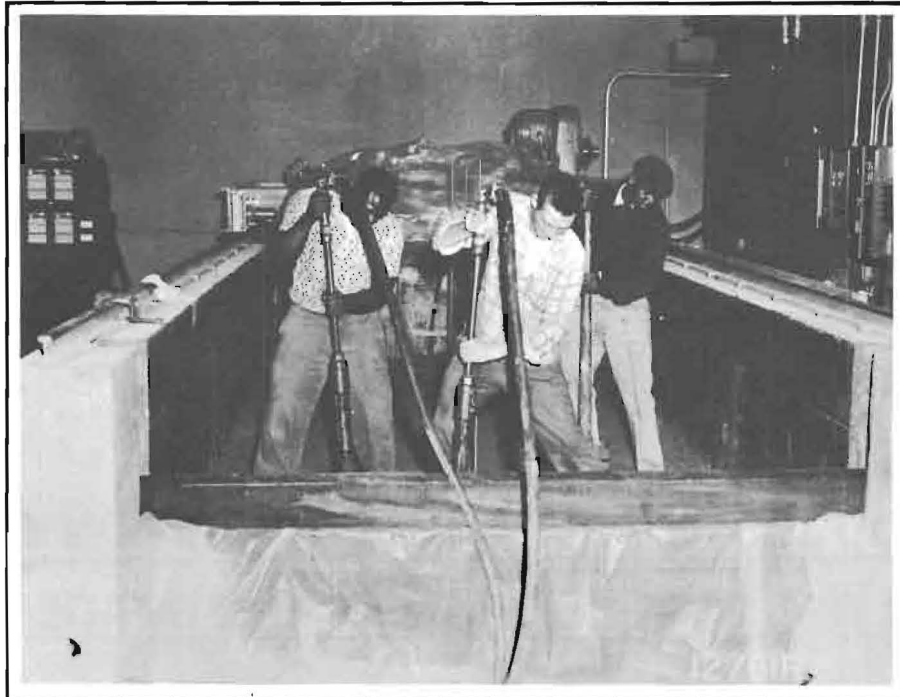
Figure 8. Compaction of the clay subgrade using pneumatic tampers.

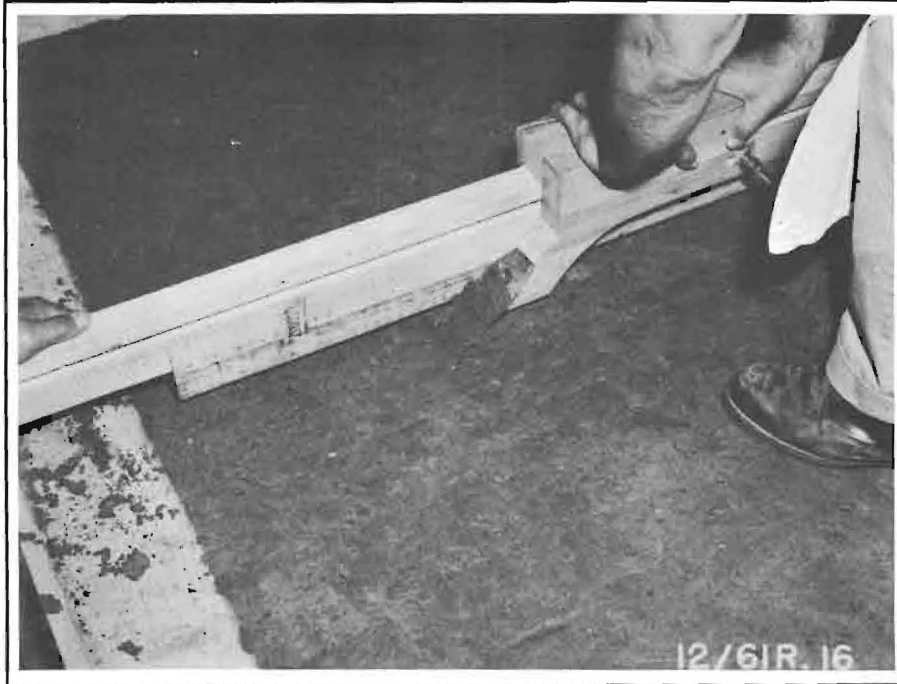
Figure 9. Subgrade planer devised for leveling the subgrade surface to provide uniform support for the test slabs.

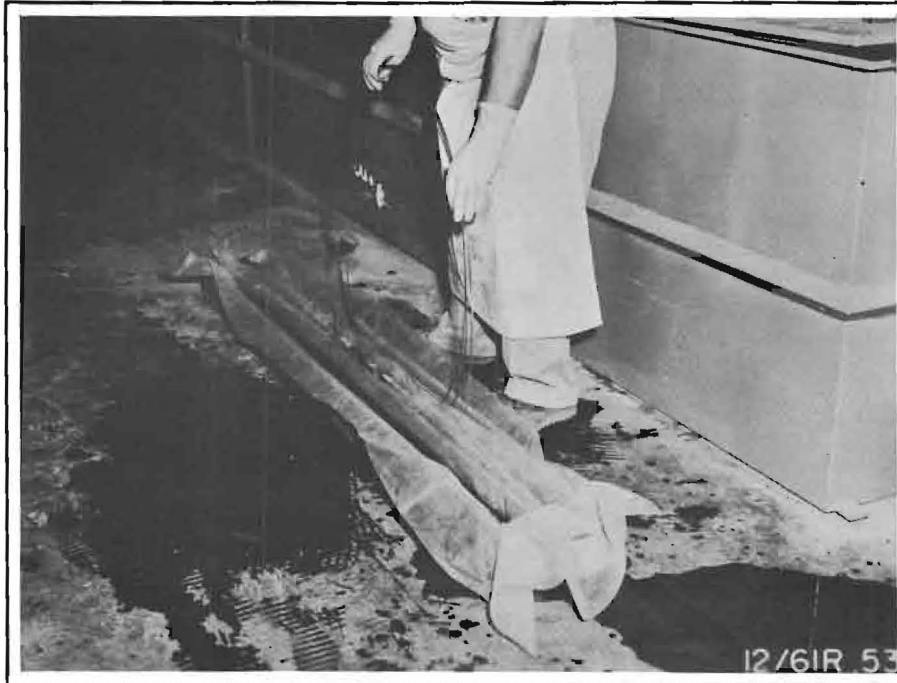
Figure 13. Dipping stressing wires in dilute hydrochloric acid to etch the surface of the wire and improve the bond between the wire and the concrete.

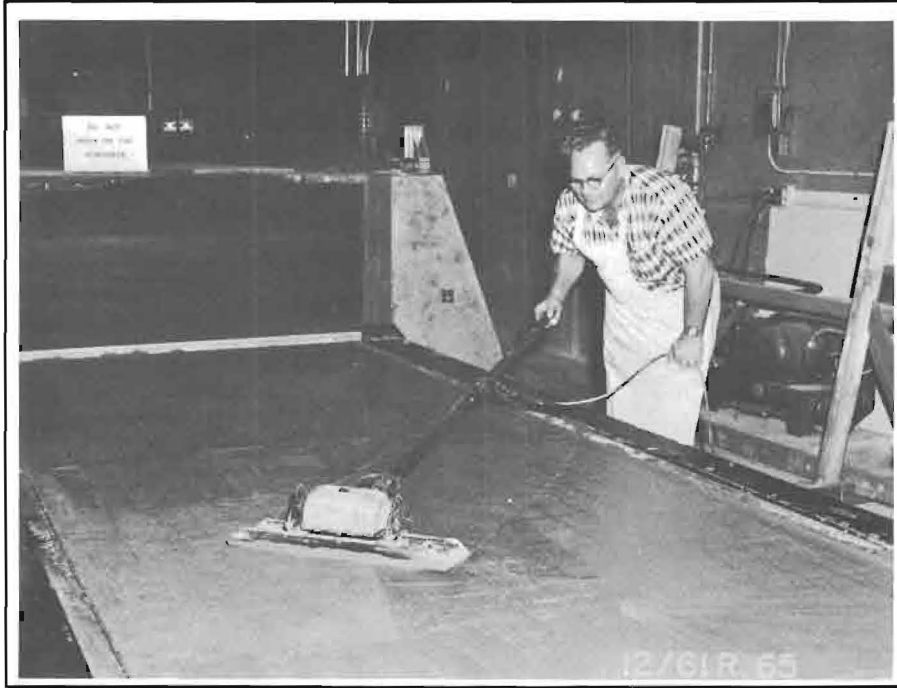
Figure 17. Plate-type vibrator being used to consolidate the concrete during construction of the test slabs.
