Precast Concrete Panel Systems for Full-Depth Pavement Repairs

Field Trials

PUBLICATION NO. FHWA-HIF-07-019

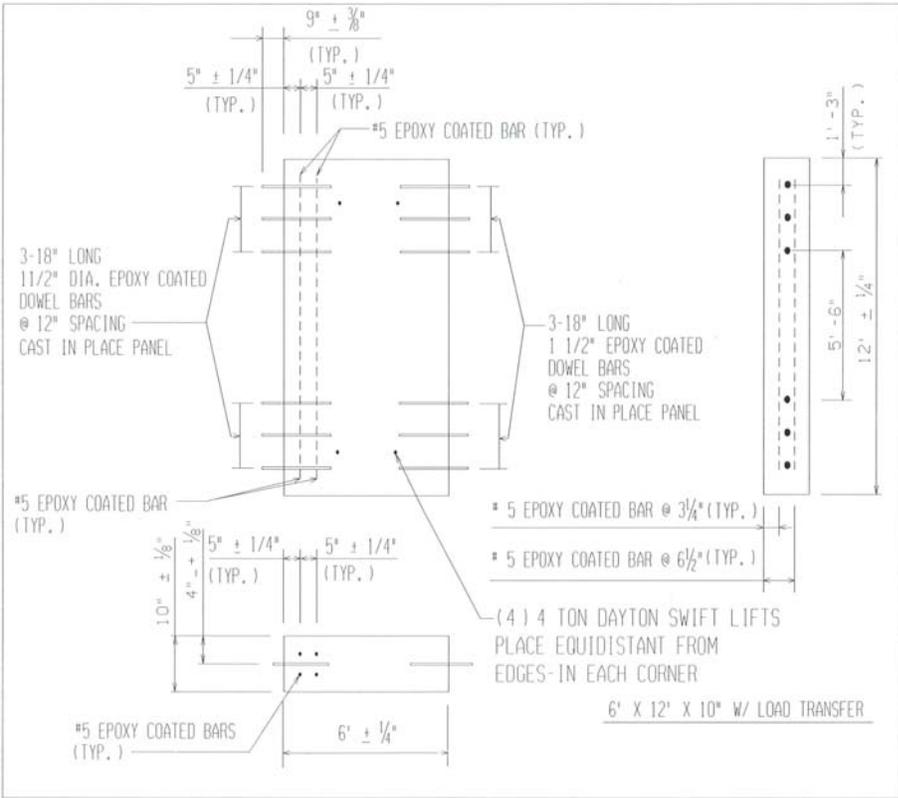
Figure 1. Structural details of the doveled precast panel.

diameter placed at 150-mm [6-in.] intervals and held together with 6-mm [0.25-in.] ties) was placed at the panel mid depth to resist the potential of early-age cracking. The panels were wet-cured for 7 days using wet burlap covers. The 20 precast panels were stockpiled at the ready-mix concrete supplier's yard. Eight panels were installed at the I-675 site, and 12 were installed at the M-25 site. The typical structural details are illustrated in Figure 1.

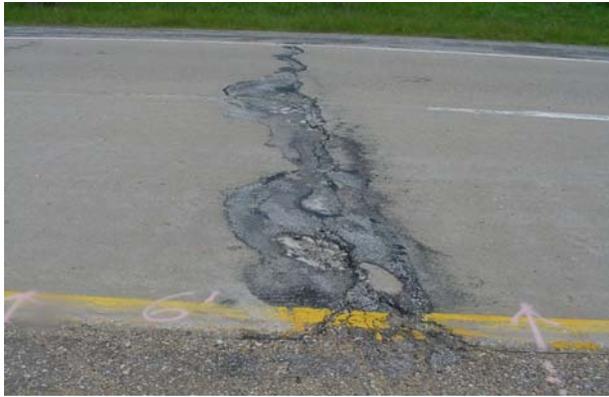
a) Deteriorated joint with cold patch with spalling.

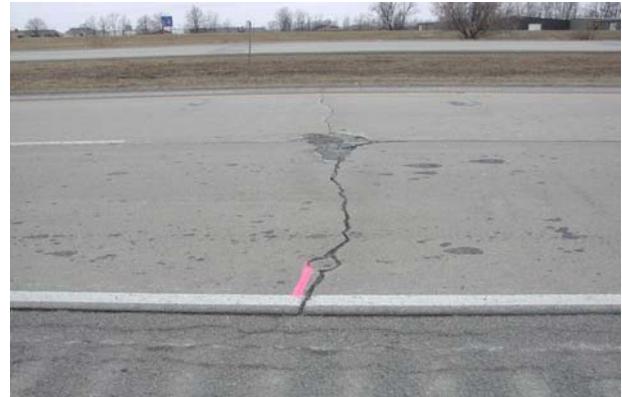
b) Medium-severity transverse crack.

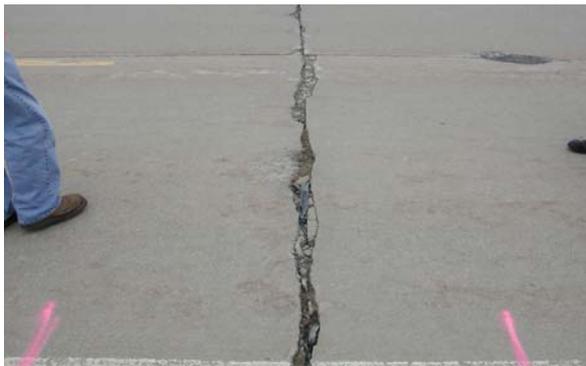
c) High-severity transverse crack.

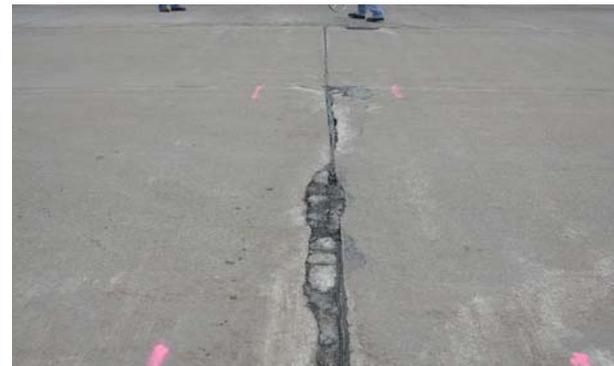
d) Deteriorated joint with spalling.

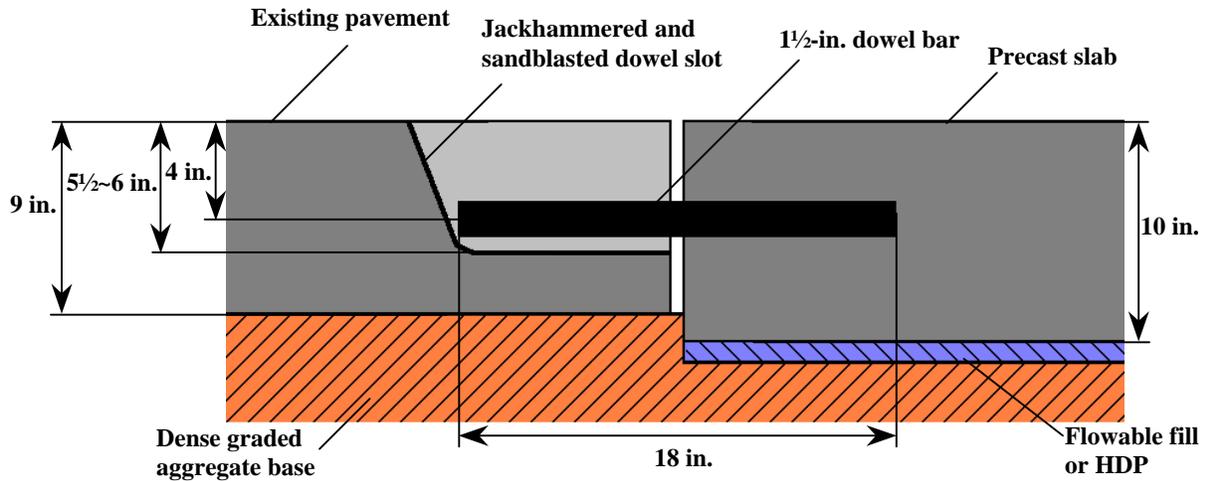
Figure 7. Schematic cross section of the dowel assembly.

The dowel slots were placed at 300 mm (12 in.) on center. The slots are 375 mm (15 in.) from the nearest longitudinal edge (shoulder or centerline). Figure 7 shows a schematic cross section of the dowel assembly.

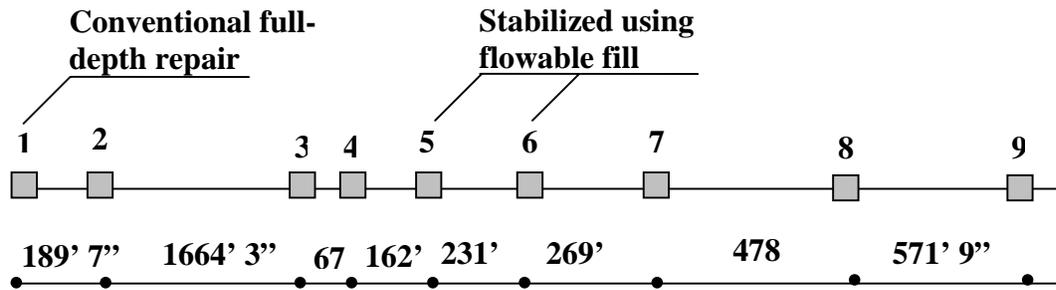
Figure 10. Relative distances of patches along the I-675 project.

For the I-675 project, all nine panels were installed in 1 day under the same traffic control due to the close proximity of the panels. Figure 10 illustrates the relative location of the precast panels. Figure 11 illustrates the timeline (typical) for the installation of panel 5.

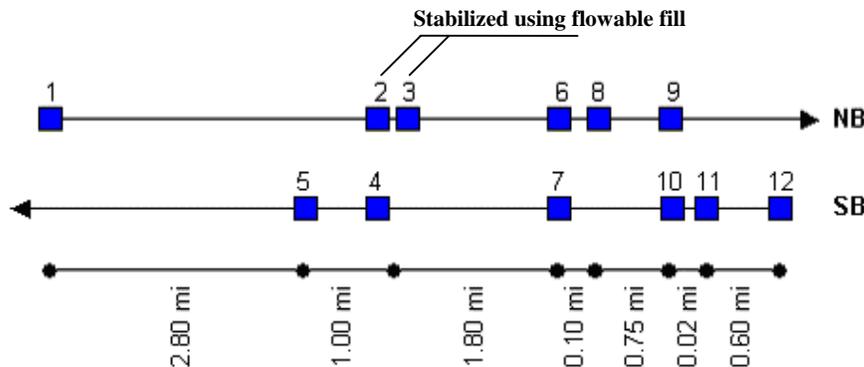
Figure 12. Relative distances of patches along the M-25 project.

At the M-25 project site, 12 precast panels were installed over a period of 3 days. Contributing to the longer installation time were the distances between some of the panels and the construction interruptions due to rain. Figure 12 illustrates the relative location of the precast panels.

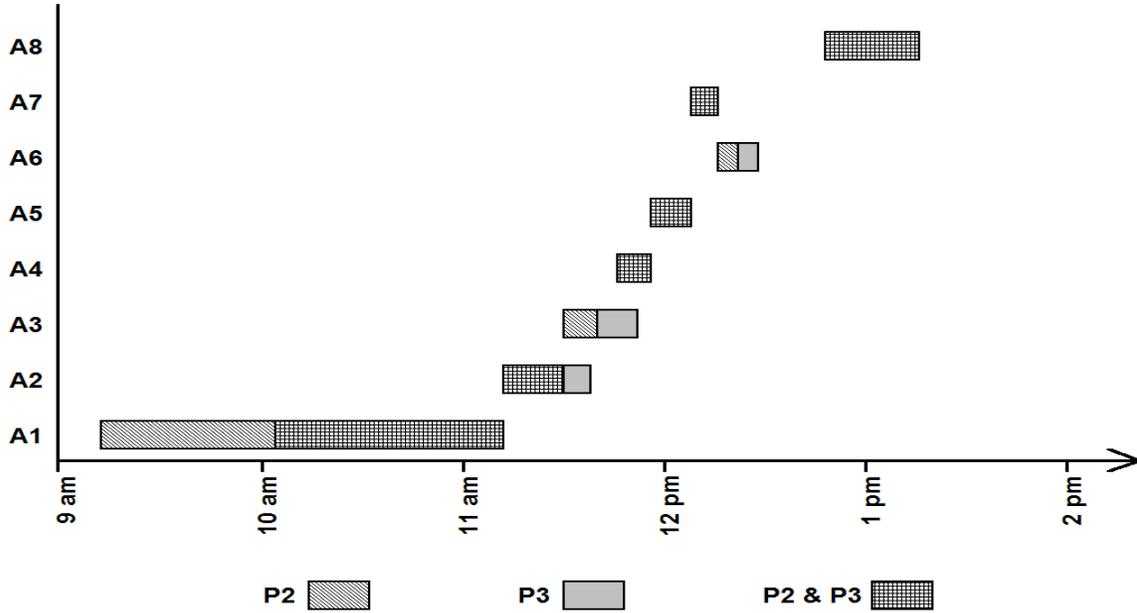
Figure 13. Construction timeline for patches 2 and 3.

Figure 13 illustrates the construction timeline for panels 2 and 3. Due to the close proximity of these panels, some of the construction activities overlap. Panels 2 and 3 were stabilized using flowable fill, and the remaining panels were stabilized using HDP foam.

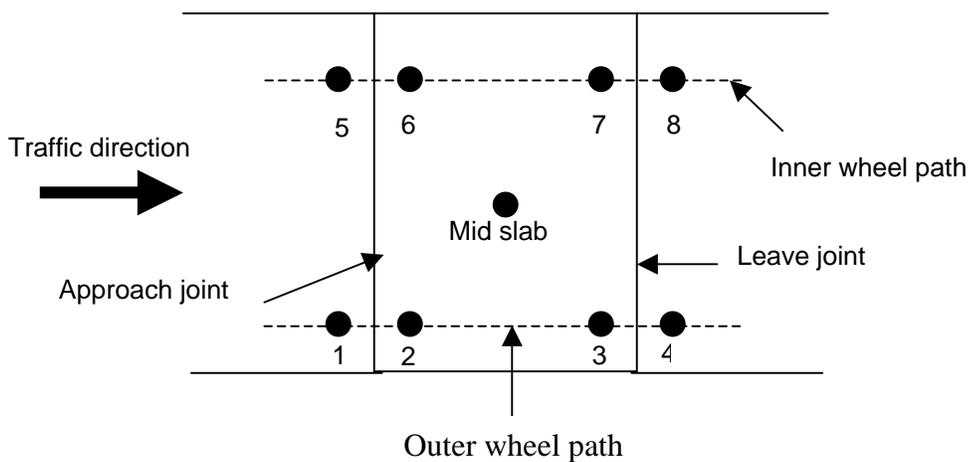
Figure 14. Falling-weight deflectometer test locations to evaluate panel effectiveness.

The repair effectiveness of the panels was determined by conducting distress surveys and falling-weight deflectometer (FWD) tests according to the protocol illustrated in Figure 14. Test locations 1 through 8 allowed for the computation of load transfer efficiency (LTE) across the approach and leave joints. The LTE was computed using the following equation, where LTE:

$$LTE_{\delta}(\%) = \frac{\delta_u}{\delta_L} \times 100$$

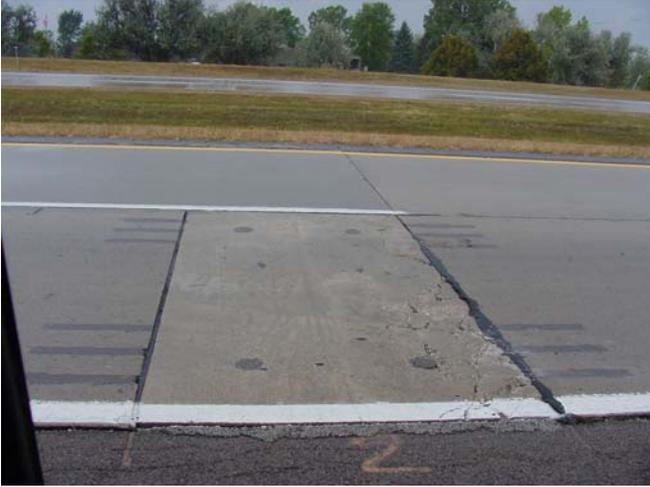
<p data-bbox="477 770 561 795">Panel 2</p>	<p data-bbox="873 506 1429 590">Panel cracking observed in the vicinity of the dowel bars. The average joint LTE is 74.5%, and the deflection ratios are less than 2.</p>

For panel 2, the average before-leave joint LTE (%) ranges from 63 to 75 whereas the after-leave joint LTE (%) ranges from 68 to 91. The type of distress observed in panel 2 looks like failure at the end of the dowels due to thermal movement of the pavement. The hot pour joint sealant is pushed up in the joint, indicating the pavement closing up on the leave side of the joint. Uniform restraint was not provided in the reservoir opening between the dowels, which may have resulted in high bearing stresses at the dowel ends. Another reason for this premature joint failure could be that the dowels along the leave joint were horizontally skewed as a result of the installation. This skewing could have resulted in “locking” of the joint and impeding joint movement under environmental and traffic loads.

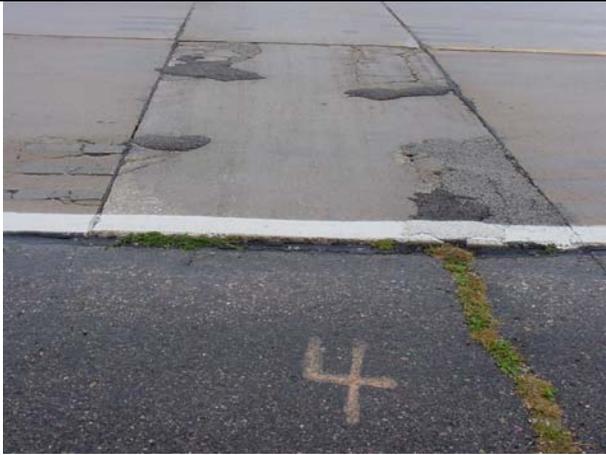
<p data-bbox="469 730 553 758">Panel 4</p>	<p data-bbox="846 443 1435 625">The repair is severely deteriorated. The cracking along the dowels was first observed during the summer of 2004. The cracking was observed along the approach and leave joint of the panel. The average joint LTE ranges from 73% to 78% and the deflection ratios are less than 2.</p>

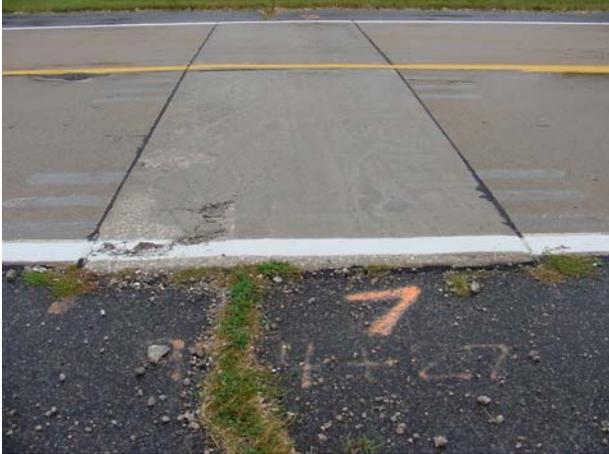
<p data-bbox="469 743 553 772">Panel 7</p>	<p data-bbox="846 470 1430 590">The panel is broken in one corner most probably due to snowplow damage, as there was a high spot along the approach joint. The average joint LTE ranges from 86% to 88% and the deflection ratios are less than 2.</p>

3. Diamond grinding of the panel, especially the joints, is recommended to remove high spots. These high spots have a potential to “break off” as a result of snowplowing operations.

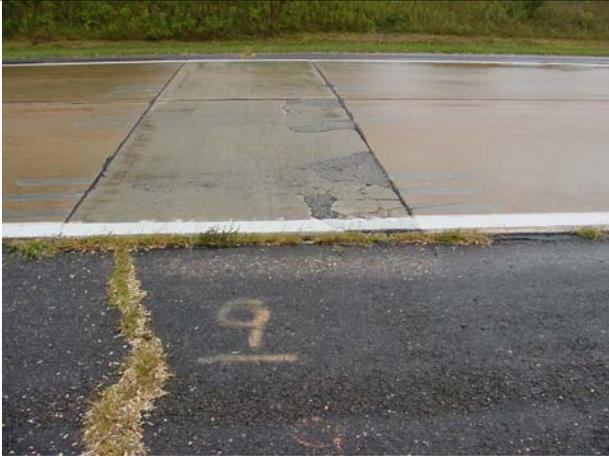
<p data-bbox="469 1774 553 1803">Panel 9</p>	<p data-bbox="846 1457 1430 1640">The repair is deteriorated. The cracking along the dowels was first observed during the summer of 2004. The cracking is along the leave joint of the panel. The average joint LTE ranges from 72% (leave joint of the panel) to 89% and the deflection ratios are approaching 3 along the leave joint of the panel.</p> <p data-bbox="1325 1759 1430 1789" style="text-align: right;"><i>continued</i></p>

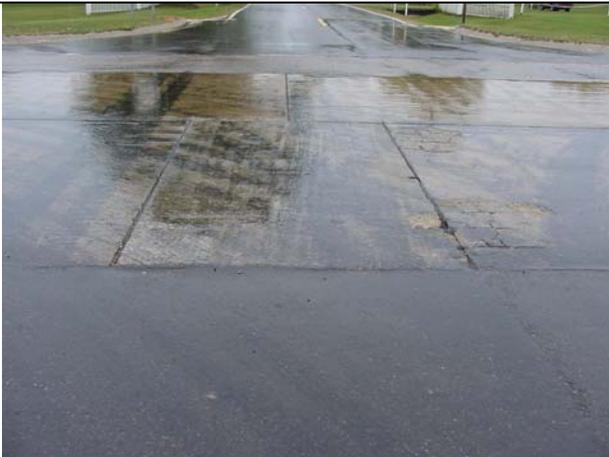
<p data-bbox="462 1766 560 1791">Panel 12</p>	<p data-bbox="846 1444 1419 1625">The panel is in acceptable condition. Trailing edge (leave joint of the panel) broken in the old concrete. The average joint LTE ranges from 62% (leave joint) to 88% and the deflection ratios are less than 2.5. However, the deflection ratio at the broken edge is approaching 3.</p>

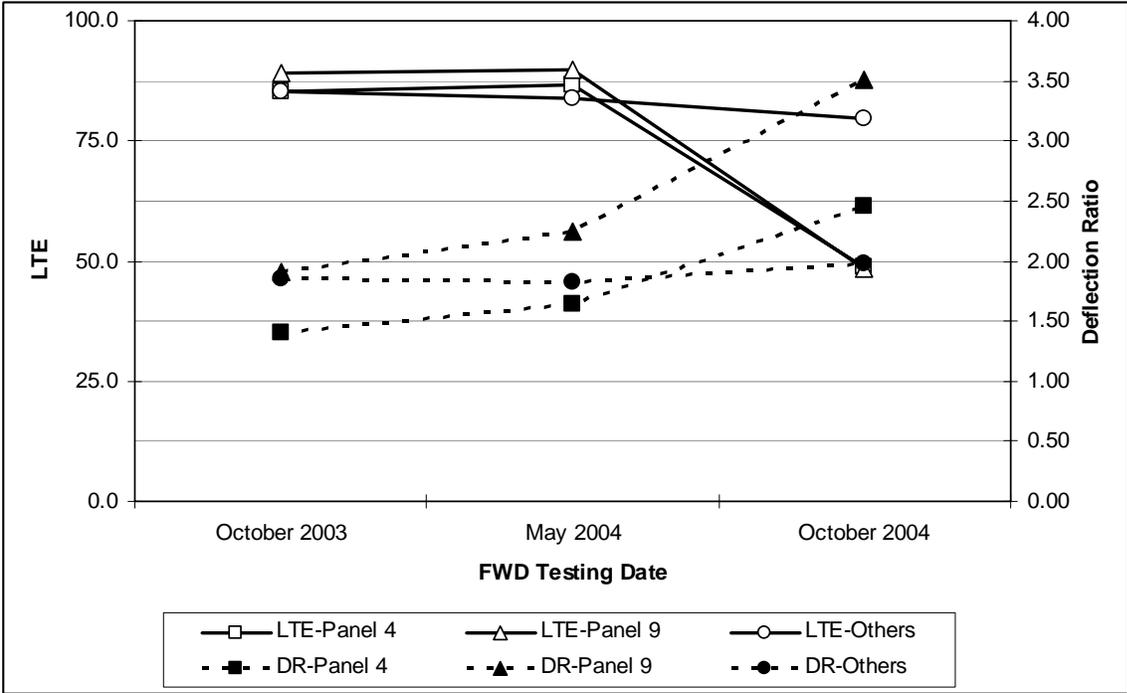
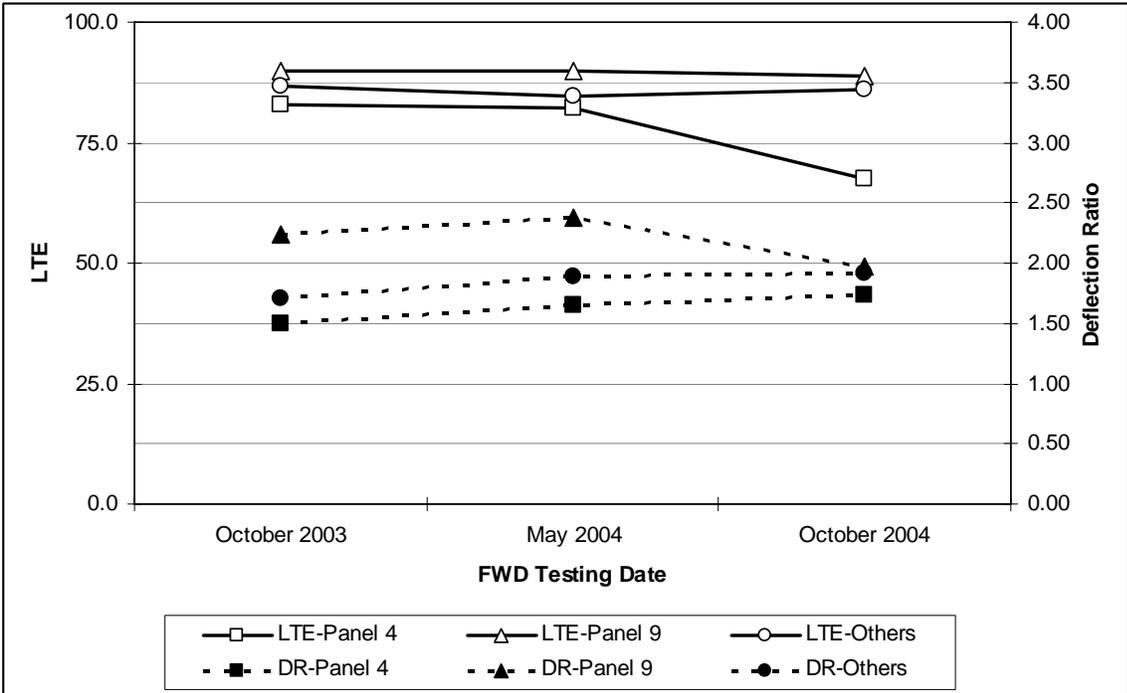
Figure 17. Structural response of panels 4 and 9.

(a) Leave Joint

(b) Approach Joint

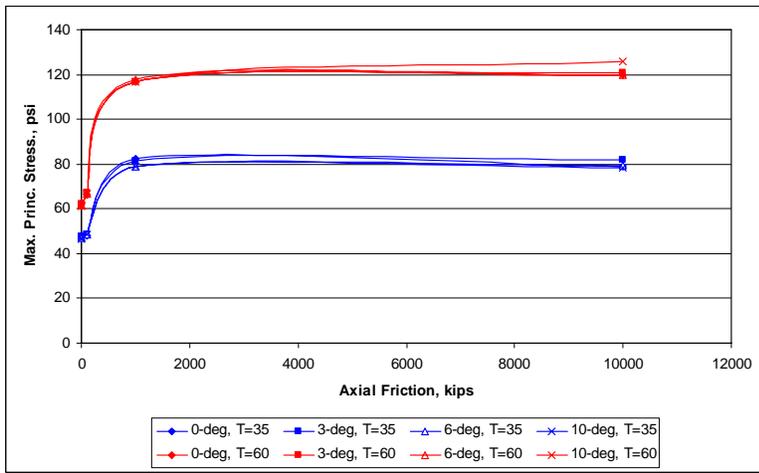
(a) Effect of temperature differential on concrete tensile stresses.

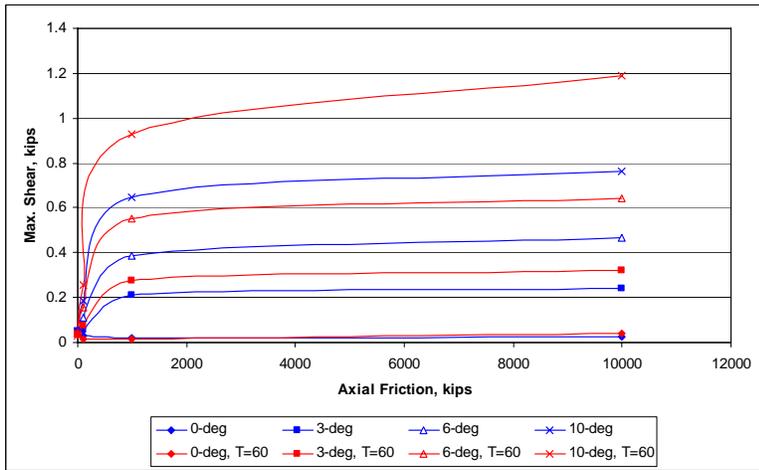
(b) Effect of horizontal dowel skewness on dowel vertical shear force.

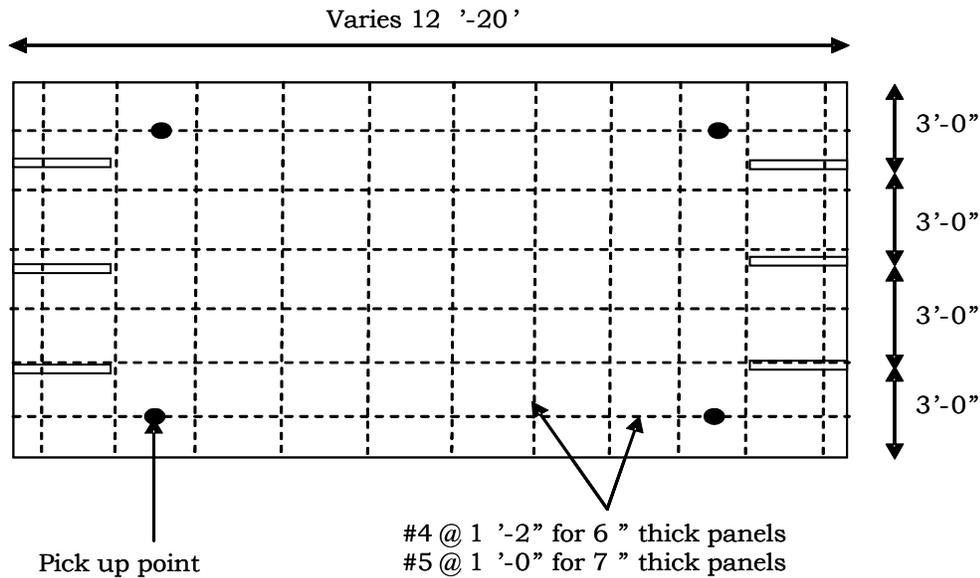
Figure 20. Structural details of the precast panel.

The precast PCC panels were fabricated by the contractor and transported to the project site. The typical structural details of the precast panels are illustrated in Figure 20. The tie bar slots, which were formed during the panel fabrication process, were placed at 0.91 m (3 ft) on center. The panel also consists of #4 or #5 steel depending on the panel thickness. The panel lengths were variable so as to match the contraction joint spacing. The typical PCC mixture designs for this study are summarized in Table 11, and the compressive strength data for the Mead and Loveland sites are summarized in Table 12.

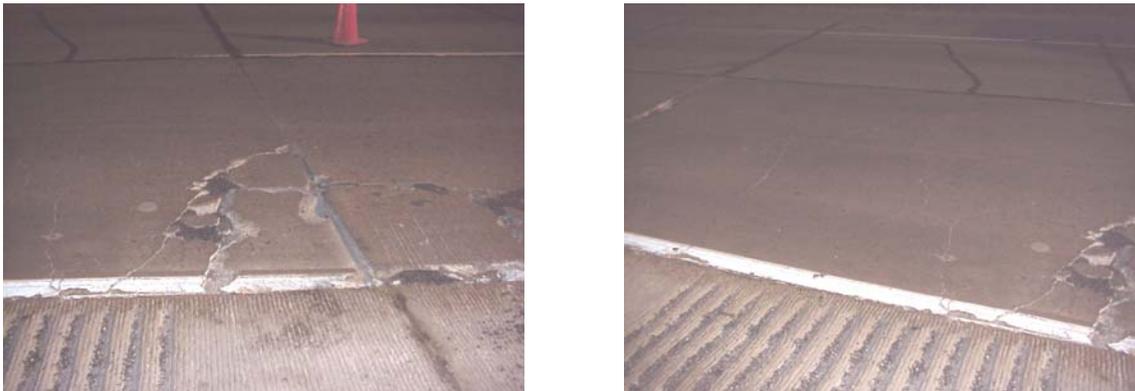
Figure 21. Examples of distresses.

Prior to the removal of the candidate panels a distress survey was conducted. Typical distresses observed during the survey included midpanel transverse cracks with associated spalling; joint sealant damage, spalling, and asphalt patch deterioration; and corner cracking. Some examples of distresses are shown in Figure 21.

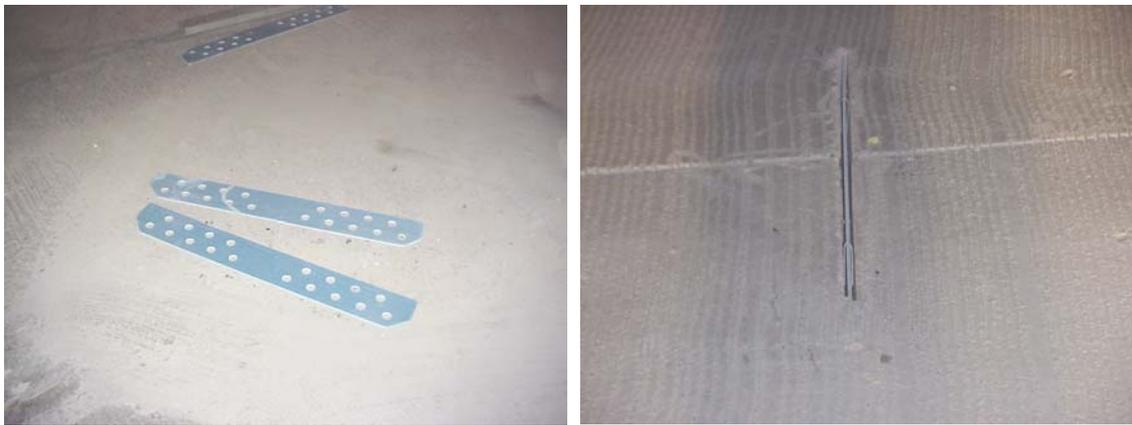
Figure 25. Fiberglass stitches.

A good bonding surface was obtained by removing all the excess foam from the joint faces and formed stitch slots. This was accomplished by using a pavement saw to cut the foam on both sides of the construction joints. The joint faces were then sandblasted to ensure clean bonding surfaces. In addition to this the surfaces were hot-air-lanced to remove all traces of moisture. Stitch slots were saw cut in the existing approach and departure slabs. The entire sawcutting was done in the absence of water to prevent reaction with the slab-jacking foam and joint-bonding material (URETEK 600).

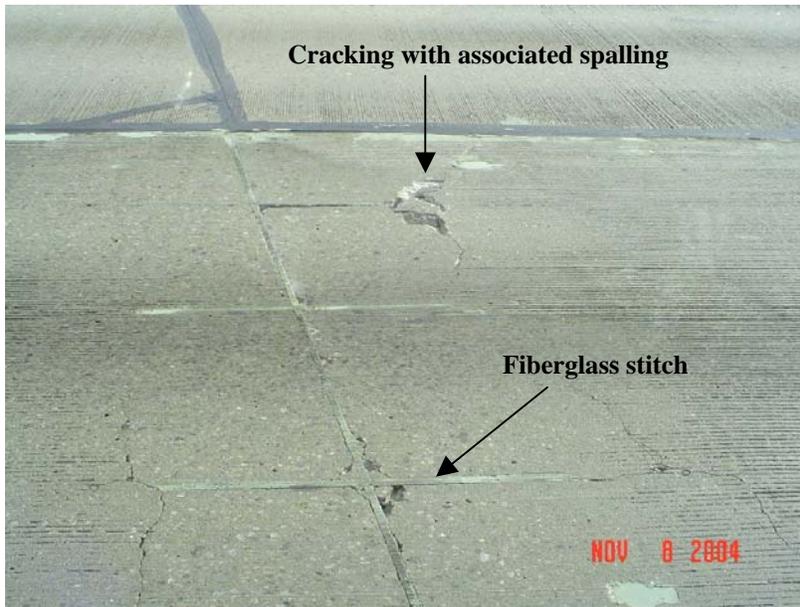
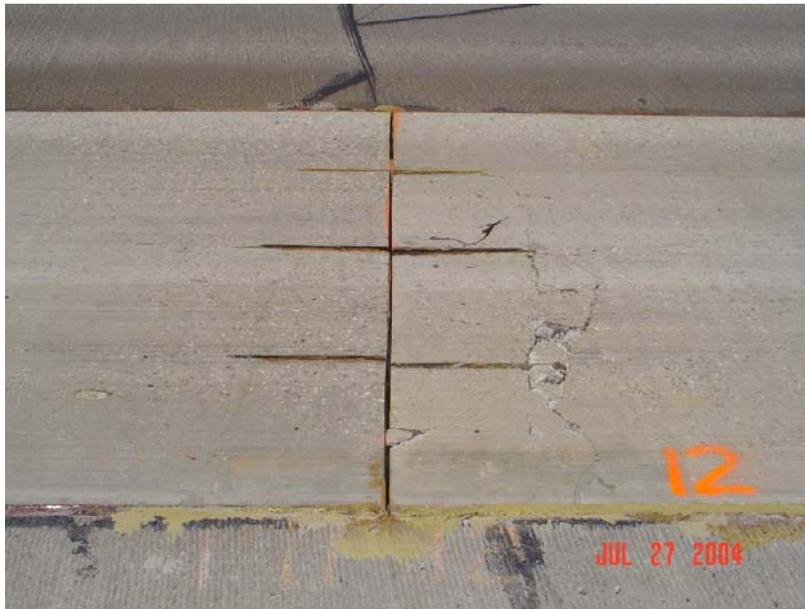
The majority of these cracks were in the vicinity of the fiberglass stitches. A typical crack pattern is illustrated in Figure 35.

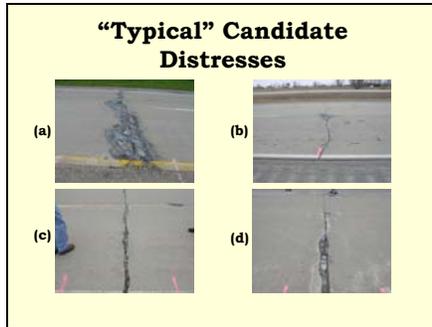
Typical distresses include (a) deteriorated joints with asphalt cold patch (b) medium severity mid panel cracking with associated spalling, (c) high severity transverse cracking, and (d) deteriorated joint (sealant damage) with associated spalling.

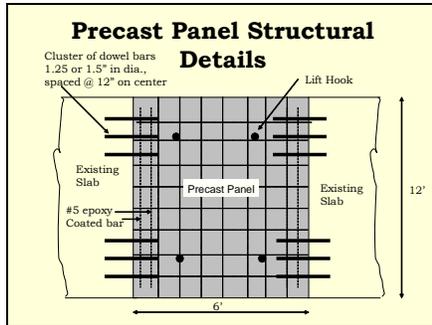
Three 1.25" diameter dowels (10" thick slab) or 1.5" diameter dowels (12" thick slab) are placed at 12" on center along the wheel path. This placement is very similar to dowel bar retrofit construction. The mid panel temperature steel is optional. The temperature steel consists of 3/8" steel bars placed at 6" on center held together by 1/4" ties. The panels are 6 feet long and 12 feet wide.

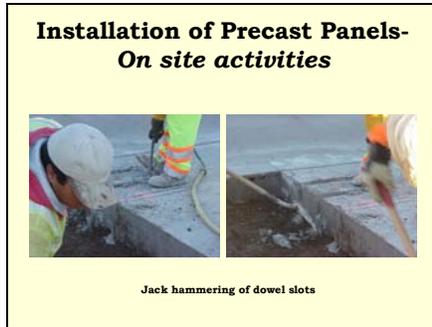
The dowel slot cutting and preparation includes (i) initial grooving to the required depth with a concrete saw; (ii) jack hammering of the concrete to carve out the dowel slot.

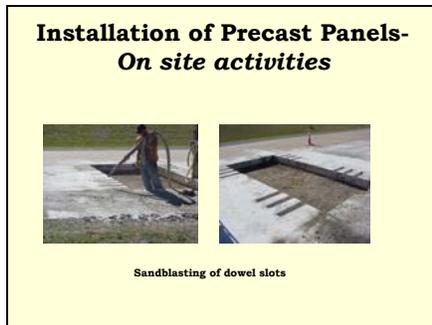
The dowel slot preparation also includes (i) air cleaning of dowel slot to remove debris and any loose concrete pieces; and (ii) sand blasting of the dowel slots. The dowel slots are approximately 4" wide and 5.25" deep (base of the slot cut).

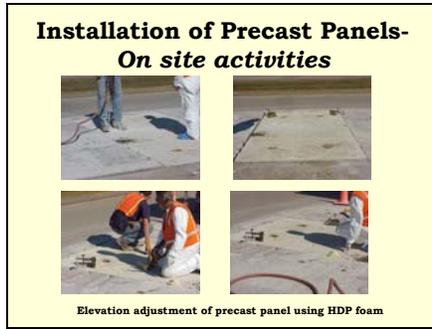
A series (approximately 4–6 holes/panel) of holes (5/8" in diameter) are drilled to inject the foam. The polyurethane foam is made from two liquid chemicals that combine under heat to form a strong, lightweight, foam-like substance. The chemical reaction between the two materials causes the foam to expand and fill the voids. According to the manufacturer's specification, the HDP foam sets in approximately 15 minutes (approximately 90% of full compressive strength), and the precast panel is ready to carry load. For the purpose of slab stabilization, the foam density is about 4 lbs/ft³ with a compressive strength range of 60 psi to 145 psi.
